# Manhole Inspection Summary

Manhole # S65U\_\_008MH

**Location** Address: **6200 Holabird Ave.**

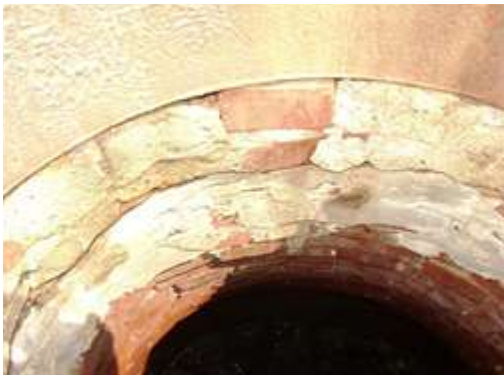
Defect 1

Infiltration: ☐ None ☒ **Joint** ☐ Cracks ☒ **Mortar** ☐ Roots ☐ Wall

Cracked mortar and loose bricks at frame adjustment.

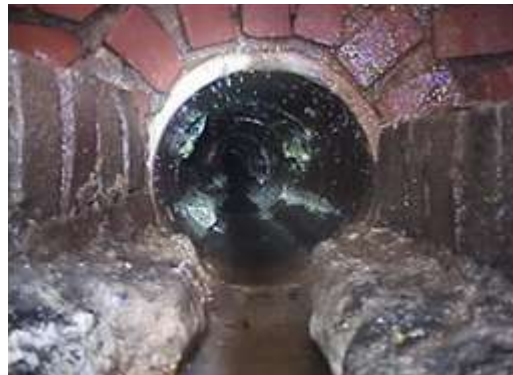
Defect 2

Comments **HEAVY GREASE DEPOSITS IN CHANNEL.**

Condition: ☐ Sound ☐ Cracked ☐ Root Intrusion ☐ Deteriorated ☐ Leaks ☒ **Debris**

Heavy grease in channel

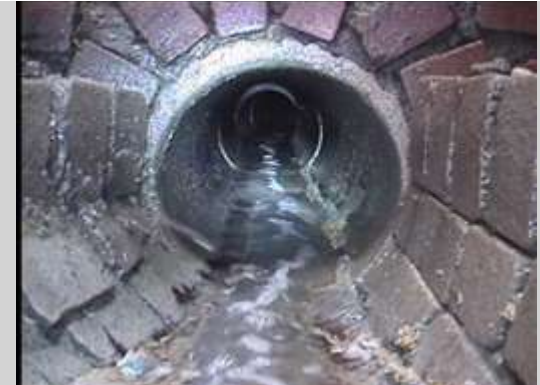
12 O'Clock Outflow

10 in. Circular Gravity Sewer  
Pipe Out @ 12 O'Clock

Pipe Height: **9.6** (in.) Rod and Bar (Angled)  
Pipe Material: **Clay** ☐ Pipe Lined  
Invert Depth: **9.33** (ft.) Flow Characteristics: **Fast**  
Deposits: ☒ None ☐ Mud ☐ Sludge ☐ Debris ☐ Grease  
Silt Depth: (in.) Deposits Extent:  
Infiltration: **None** Pipe Seal Cond: **Sound**

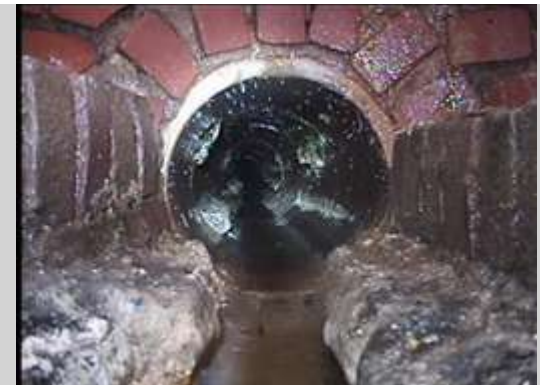
6 O'Clock Inflow

10 in. Circular Gravity Sewer  
Pipe In @ 6 O'Clock

Pipe Height: **9.6** (in.) Rod and Bar (Angled)  
Pipe Material: **Clay** ☐ Pipe Lined  
Invert Depth: **9.17** (ft.) Flow Characteristics: **Slow**  
Deposits: ☒ None ☐ Mud ☐ Sludge ☐ Debris ☐ Grease  
Silt Depth: (in.) Deposits Extent:  
Infiltration: **None** Pipe Seal Cond: **Sound**

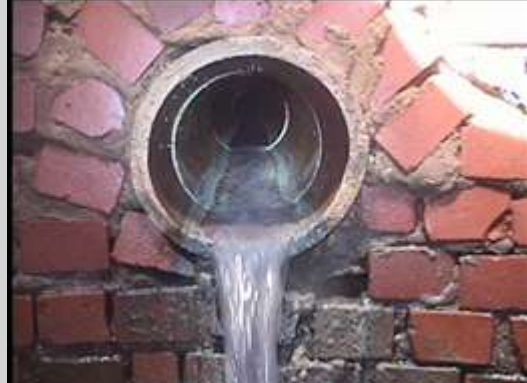
9 O'Clock Inflow

8 in. Circular Gravity Sewer

Pipe In @ 9 O'Clock

Pipe Height: **8.4** (in.) Rod and Bar (Angled)

Infiltration: **None** Pipe Seal Cond: **Sound**
